VENETIAN TASK

Moving a 22t drill rig for work in
Venice's historic St Marks Square

An intricate operation was needed to get a drill rig into position for work on the foundations of the bell tower in St Mark's Square, Venice. *EF* reports.

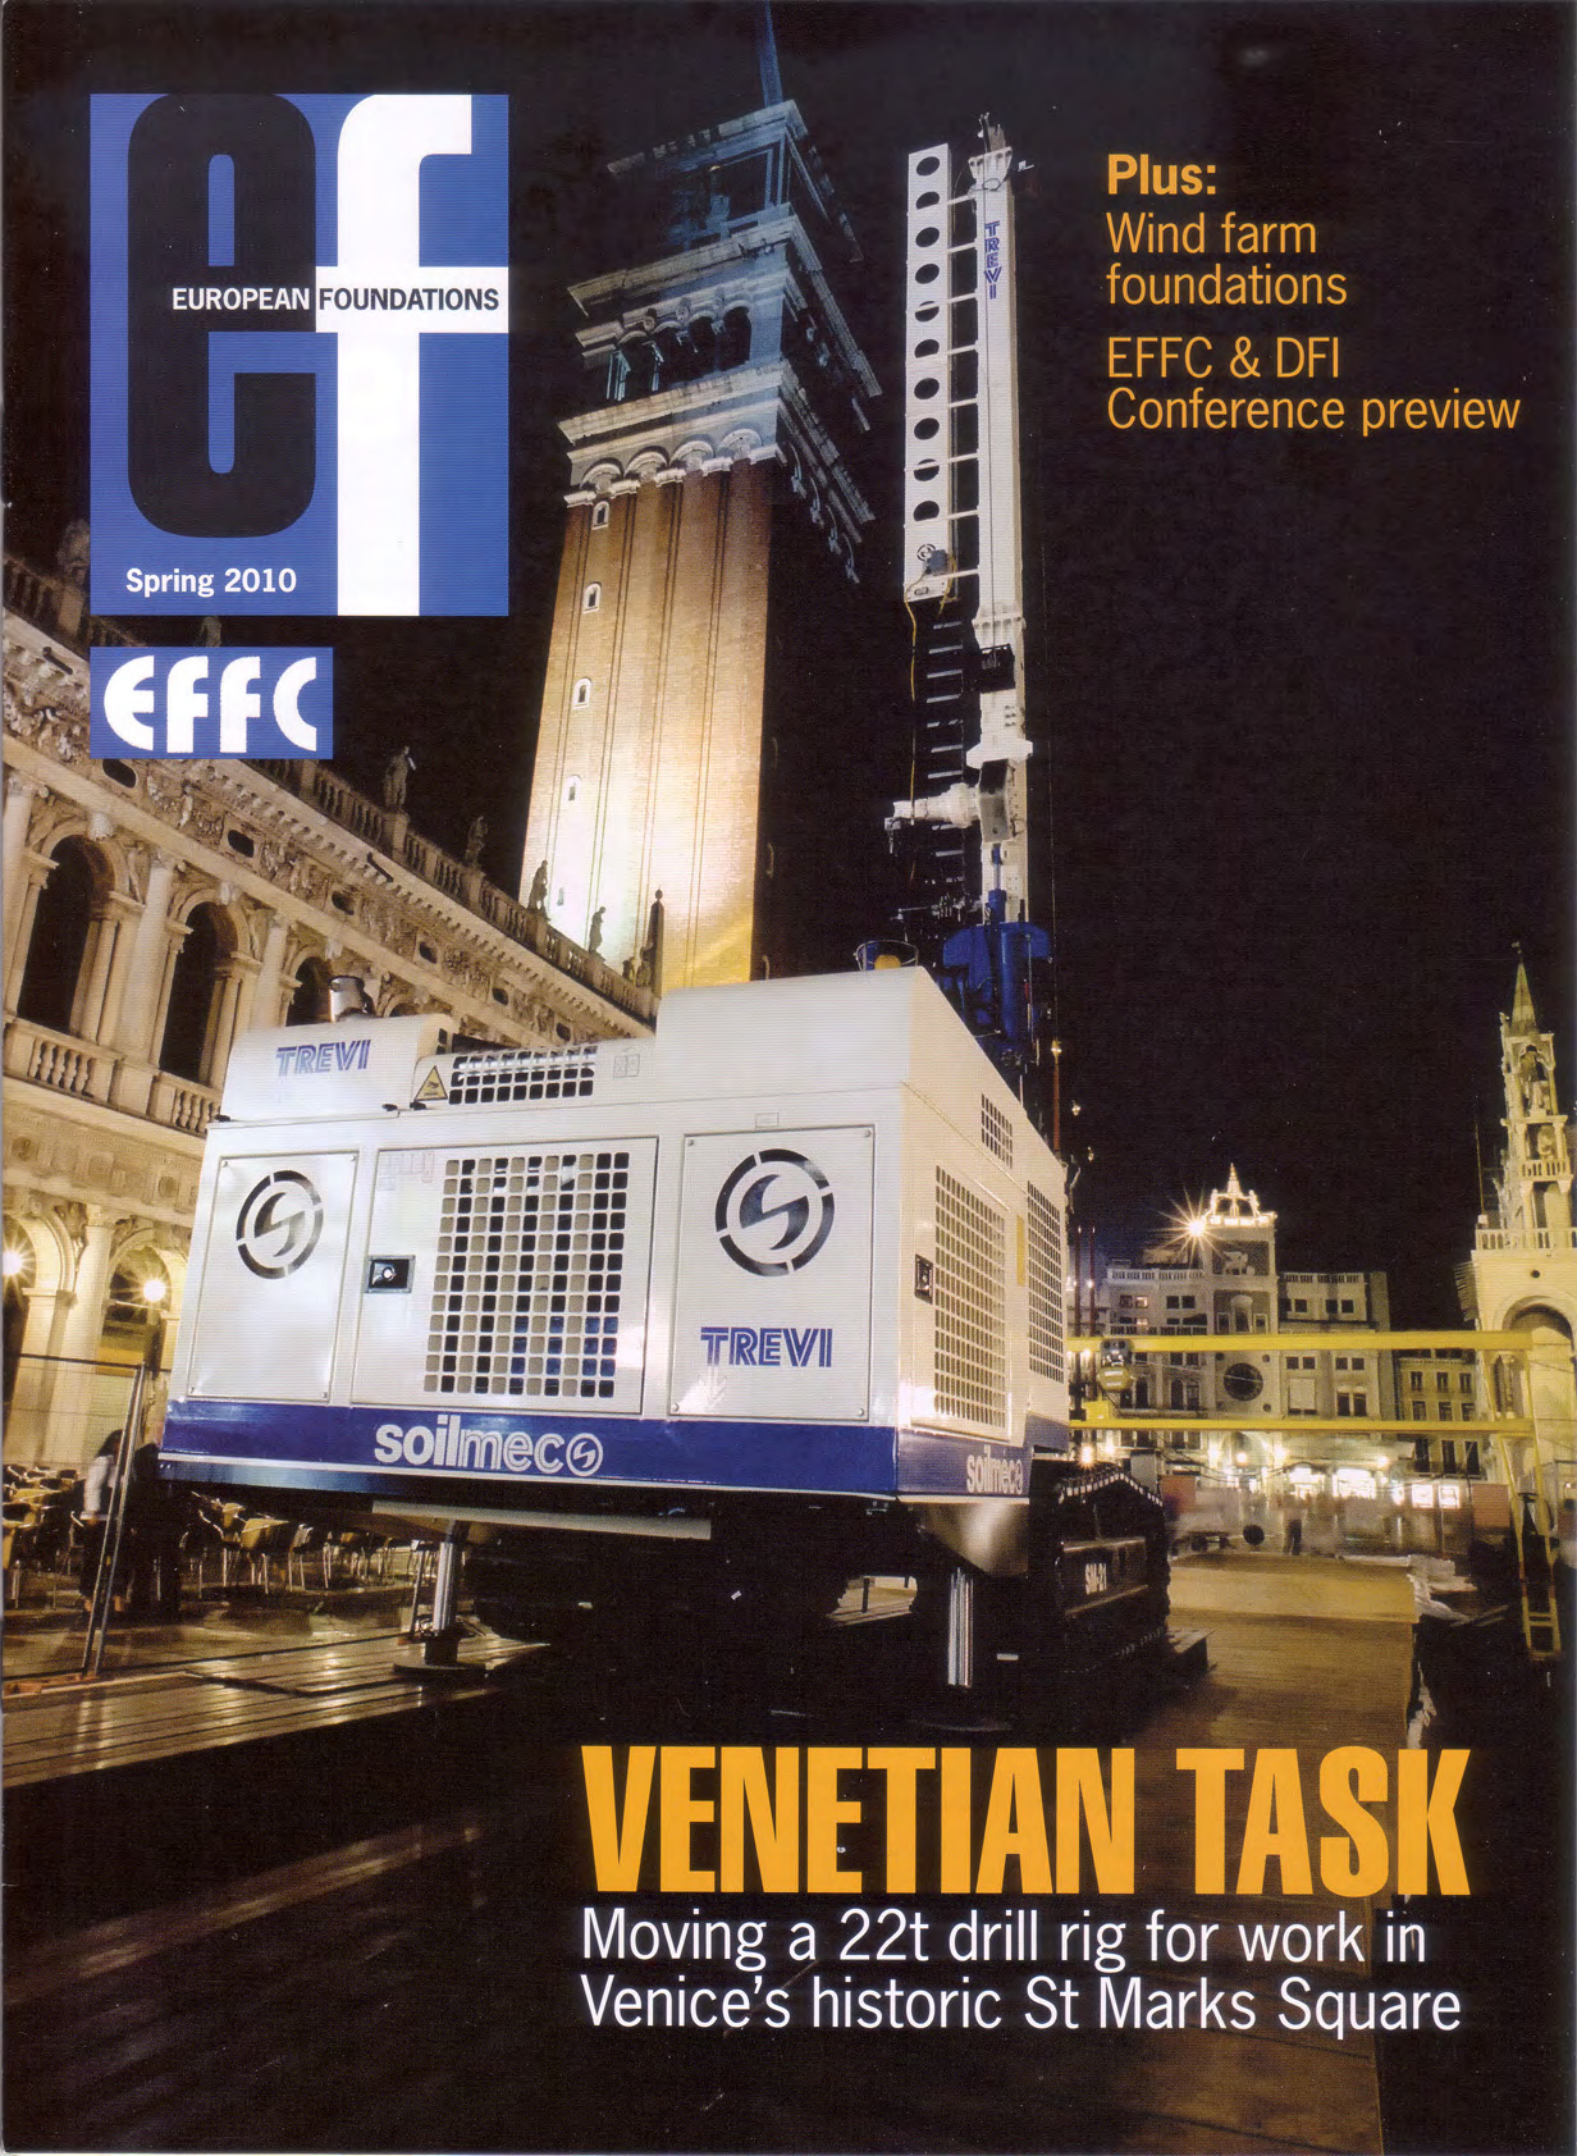
The bell tower today is slightly out of plumb, a defect that can be seen from certain angles even with the naked eye

Moreover, the bell tower today is slightly out of plumb, a defect that can be seen from certain angles even with the naked eye – possibly further proof that the loads are not perfectly distributed at the base of the structure.

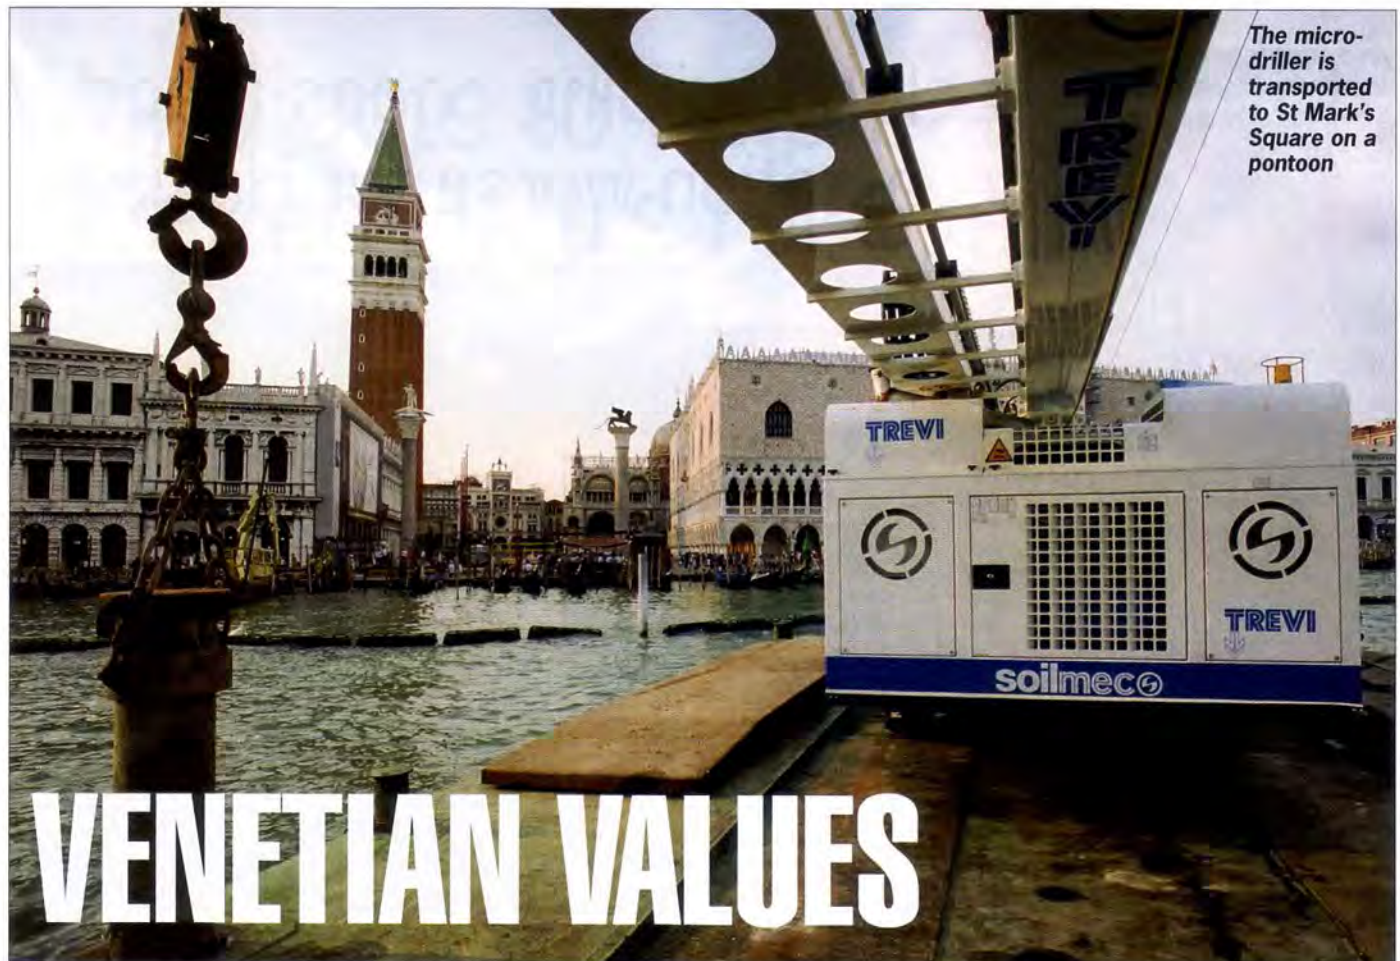
The micro-driller is transported to St Mark's Square on a pontoon

The machine was delivered to the site in early August 2009 after a major logistical exercise to work out how to get it into the centre of the historic square. It arrived at San Marco by water, having been loaded onto a pontoon at the pier at Cavallino Treporti, on the edge of the Venice lagoon.

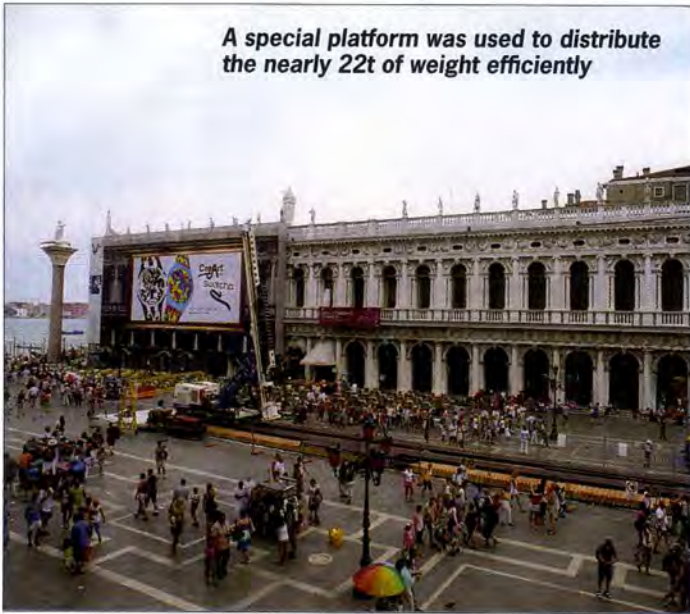
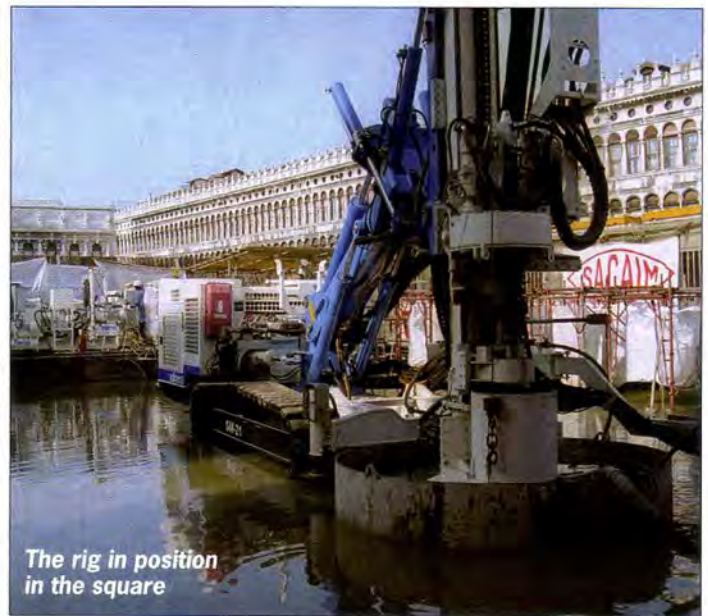
A special platform was used to distribute the nearly 22t of weight efficiently

The rig in position in the square

A platform capable of distributing the loads was built using 150mm of sand and a layer of neoprene, covered with wooden beams, over which were placed I-beams. To avoid their movement during the move, the I-beams were blocked laterally with retainers anchored to the wood beams.

The platform could not cover the entire 160m of the route, so the drilling machine was moved in four stages of 40m each, which also minimised inconvenience to tourists. After each stage the platform was disassembled, then reassembled in front of the machine, and in less than a week it arrived at its destination.
