Micro-Piles Stabilize Venice Bell Tower

Cement-reinforced piles provide watertight enclosures for girdles of titanium rods to pin faulty foundations

02/03/2010

By [Peter Reina](#)

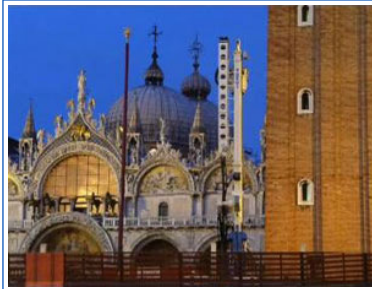
Fixing Italy's Slightly Leaning Tower, in Venice

Read the story and watch the video about repairs to reinforce the St. Mark's Square tower, which has suffered differential settlement and cracking.

The new round of remedial work will involve reinforcing the enlarged foundation by ringing it with two layers of stressed 6-cm-dia titanium rods in pairs. One level will be some 40 cm below the paving and the second about 2.3 m down.

Rods will be drilled through the soil and bolted together in lengths of 2 to 3 m. They will be anchored at the foundation's corners by titanium plates and stressed to an initial 250 kilonewtons each, according to CVN engineers. Then, depending on the foundation's structural responses, stresses will be progressively increased over a few years.

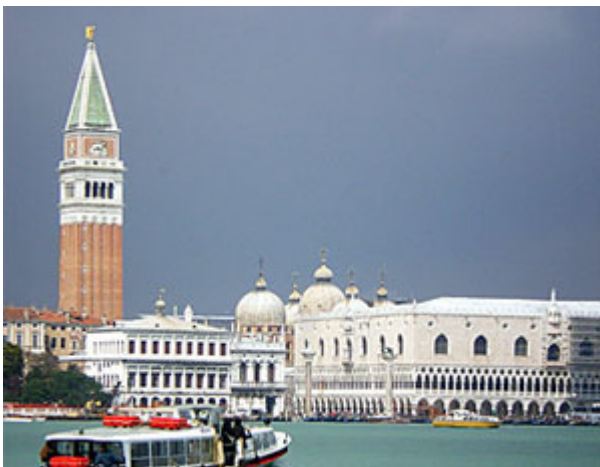
The most prominent monument in St. Mark's Square in Venice is a 20th-Century reconstruction

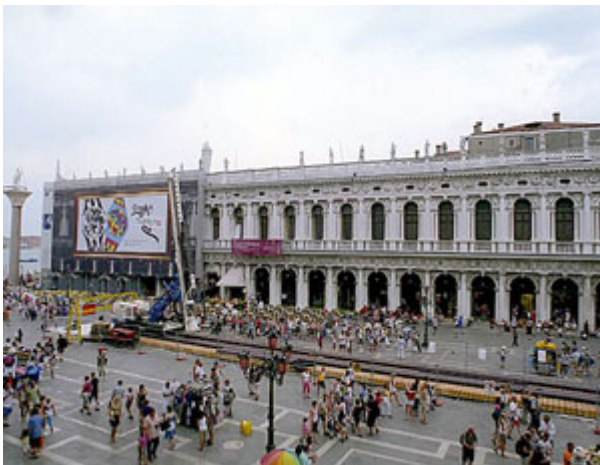
The Soilmec SM 21 rig made its dramatic entrance last summer, crawling 160 m across the square on a protective runway of sand, neoprene and timber.

Months of discussions with civil servants went into selecting a drill rig that would cause the least damage to the square. Officials initially wanted a 10-tonne machine to be used but compromised on one just over 20 tonne, says Vanni. A rig of up to 100 tonnes normally would be used for deep mixing, he adds.

The chosen Soilmec SM 21 rig made its dramatic entrance last summer, crawling 160 m across the square on a protective runway of sand, neoprene and timber. After site trials, the rig began drilling at the north-east chamber a few weeks ago.
