REFERENZA TECNICA - TECHNICAL REFERENCE

Remediation work Arapuni Dam

Waikato, New Zealand

**Diaframmi
Cut-off Walls**

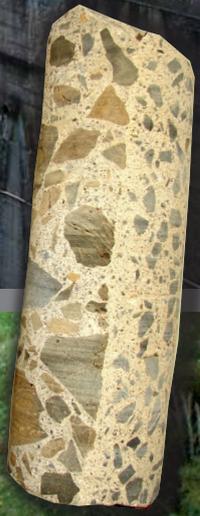
A core sample made from the dam concrete mixed with the 'new' concrete of the panel executed.

g. A properly designed concrete mix and tremie method were adopted with associated monitoring and comparison with theoretical expectations. Concrete quality was also checked by drilling down through the completed cut-off wall and testing core samples.
