CASE HISTORY

Landfill cleanup and reclamation

# Manfredonia

Directional Drilling

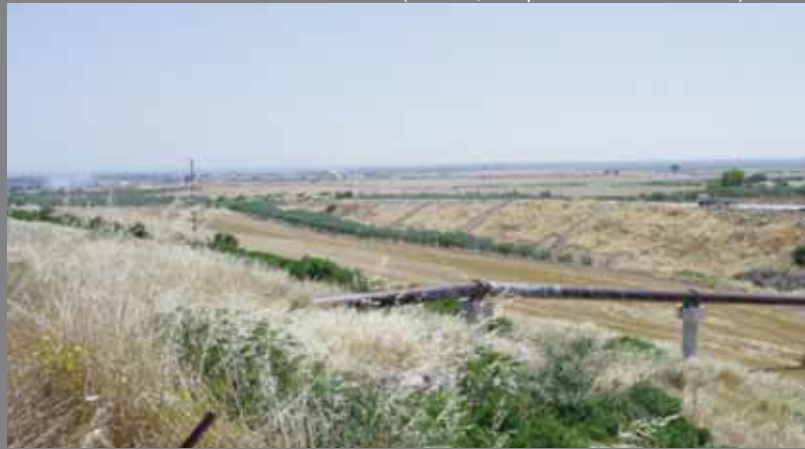
The sites are actually two abandoned calcarenite mines (soft, yellowish, tufaceous limestone) which are located at different heights, respectively on the hydrographic right and left of a small gorge dividing them and named Vallone di Mezzanotte (see photo). The two landfills are about 25,000 sqm

Vallone di Mezzanotte - Lato mare (a destra, il corpo della discarica Pariti 1)

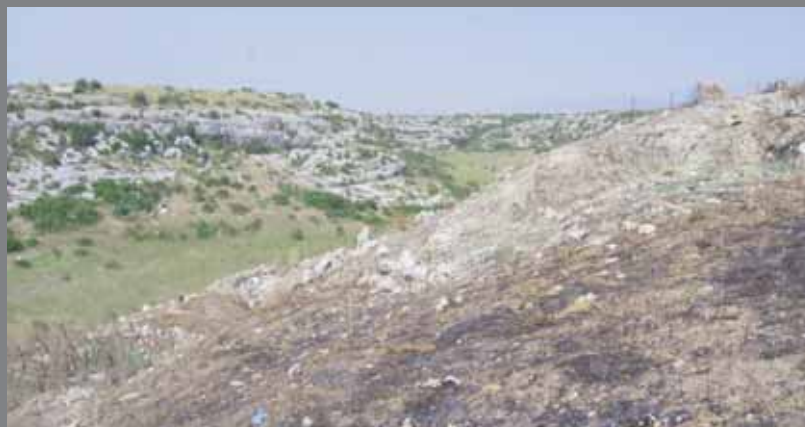
Vallone di Mezzanotte - Lato monte
